**MITIGATION OPTIONS FOR FISH AND WILDLIFE  
RESOURCES AFFECTED BY PORT AND OTHER  
WATER-DEPENDENT DEVELOPMENTS IN  
TAMPA BAY,  
FLORIDA**

Biological Report 86(6)  
June 1986

R. Steve Dial and Donald R. Deis  
Continental Shelf Associates, Inc.  
759 Parkway Street  
Jupiter, FL 33477

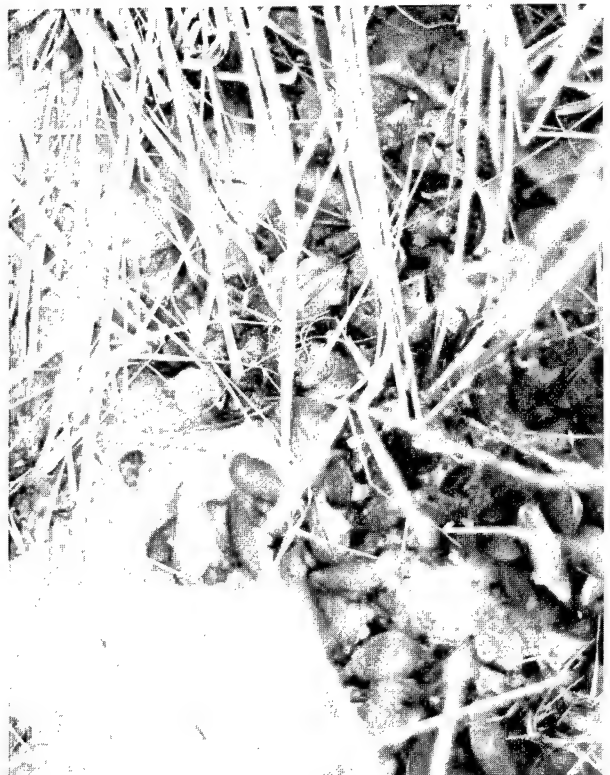
Fishes and wildlife observed during the assessment included Eucinostomus argenteus (spot-fin mojarra) in the Palm River, Geukensia demissa (ribbed mussel) attached to the base of the S. alterniflora (Figure 7), and Littorina anquilifera (marsh periwinkle) on the stems. Many Uca spp. (fiddler crab) holes were observed in the S. alterniflora band.

**Figure 7.** Ribbed mussels (Geukensia demissa) attached to base of Spartina alterniflora.

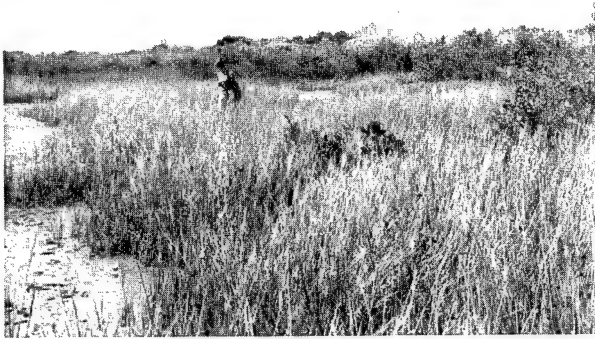
at 1130 hours (approximately low tide), 6 years after planting. Overall, Sunken Island was the most diversified restoration project visited during this survey due to the combination of many different kinds of habitats found there (i.e., S. alterniflora marsh, mangroves, upland, open sand beach, shallow intertidal, and subtidal) (Figures 22, 23, and 24). The S. alterniflora plugs had coalesced into a marsh and R. mangle, A. germinans, and L. racemosa seedlings had recruited and reached 0.5 to 1.5 m in height (Figure 22).

**Figure 22.** Sunken Island restoration area, 28 November 1984, with band of Spartina alterniflora and higher marsh of Avicennia germinans, Laguncularia racemosa, and Paspalum vaginatum.

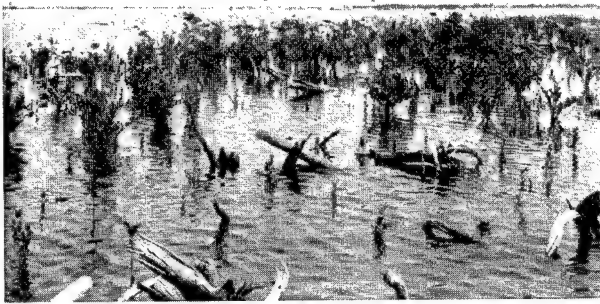
**Figure 27.** Frandorson property 9 months following restoration. Majority of seedlings are white (*Laguncularia racemosa*) or black (*Avicennia germinans*) mangroves from natural recruitment or new growth from remaining root stock.

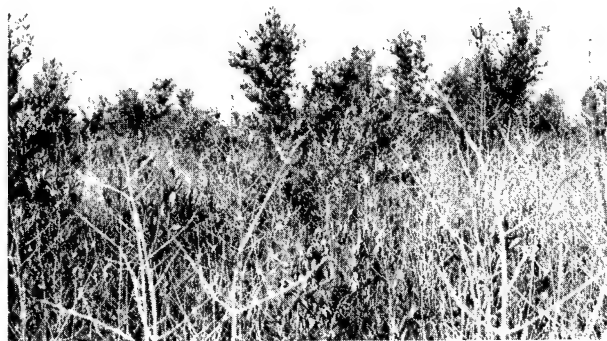
**Figure 29.** Mangrove habitat at east end of transect, 28 November 1984, 10 years after illegal clearing. Freeze-damaged white (*Laguncularia racemosa*) and black (*Avicennia germinans*) mangroves in foreground and taller red (*Rhizophora mangle*) and white (*L. racemosa*) mangroves in background.

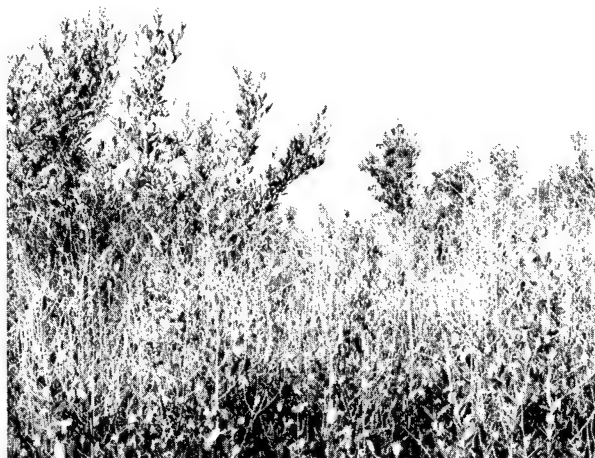
**Figure 30.** Mangrove community at west end of transect, 28 November 1984, dominated by red (*Rhizophora mangle*) mangroves in foreground and dense black (*Avicennia germinans*) and white (*Laguncularia racemosa*) mangroves in background.

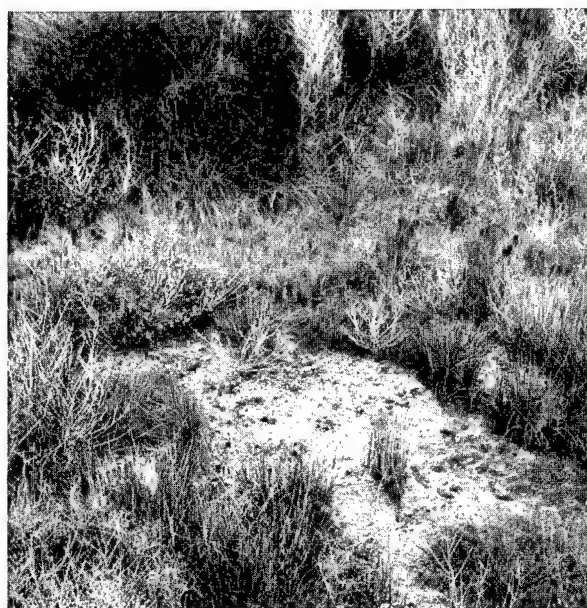
**Figure 35.** Area of unsuccessful Juncus roemerianus restoration, dominated by Salicornia virginica, Paspalum vaginatum, and stunted J. roemerianus.

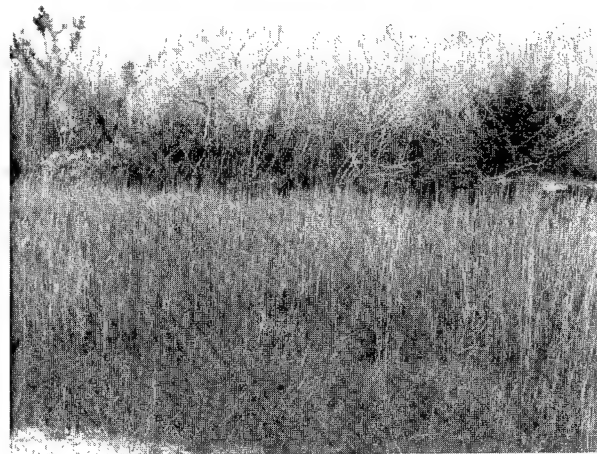
**Figure 37.** Transect 4 in the area previously restored in May 1983 (*Spartina alterniflora*, *Paspalum vaginatum*, and *Salicornia virginica*) at Feather Cove; adjacent mangrove habitat in background.

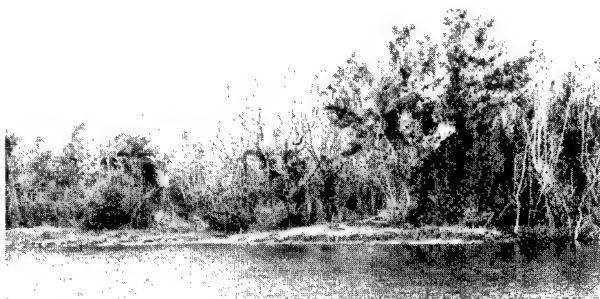
**Figure 38.** Area (Transect 1) planted with Spartina alterniflora 12 May 1984, as observed on 29 November 1984. Mangrove habitat in background shows existing habitat prior to unauthorized clearing.

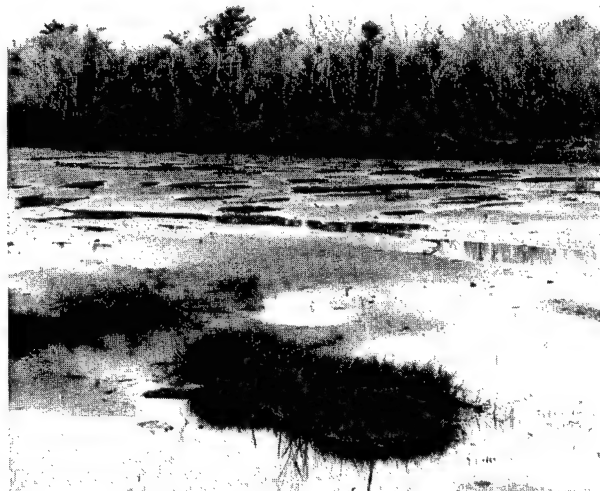
**Figure 39.** Area (Transect 2) planted with Spartina alterniflora 12 May 1984, as observed on 29 November 1984. A few sprigs are noticeable in the background, with Paspalum vaginatum in higher area.

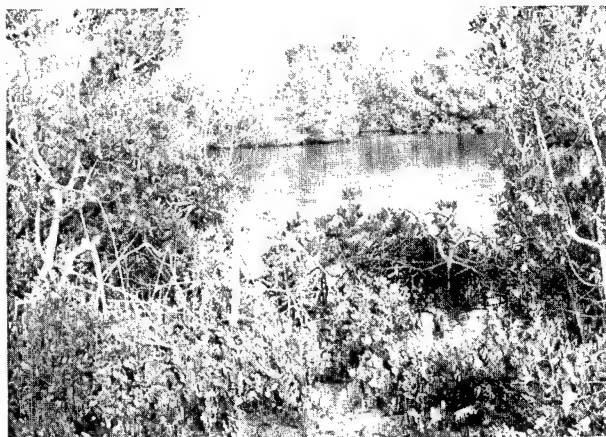
**Figure 44.** Illegal mangrove trimming by private homeowner; north shoreline of Harbor Island's mitigation area.

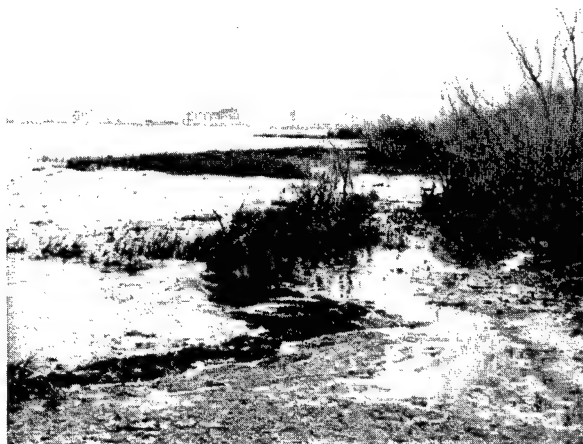
**Figure 72.** Shoreline near Gardinier, Inc. gypsum pile with fringing *Spartina alterniflora* marsh, drift algae (*Ulva* sp.), and freeze-damaged mangroves.

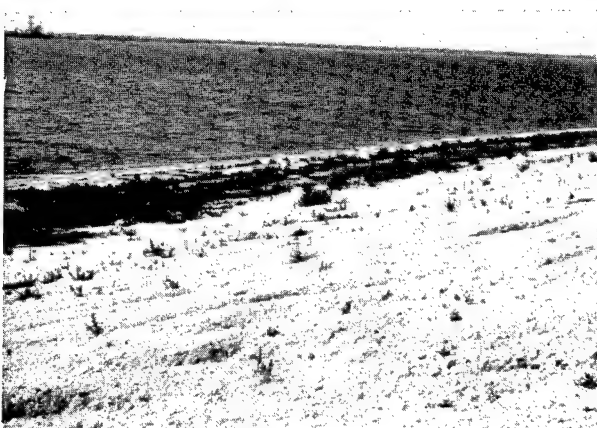
**Figure 79.** Southeastern side of Spoil Island 3-D showing narrow littoral zone.

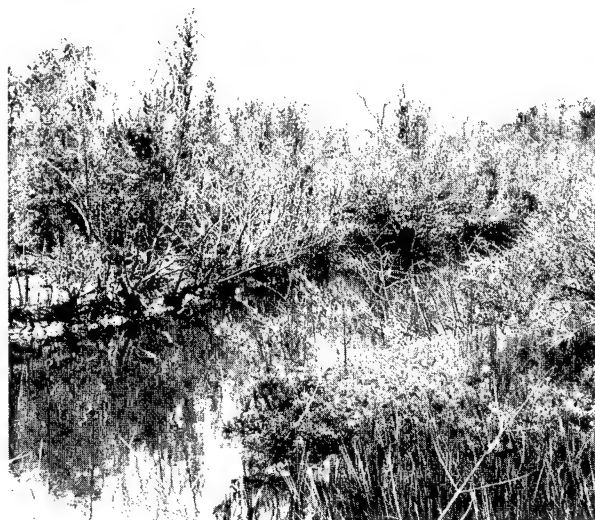
**Figure 95.** Interior tidal creeks at Booth Point showing freeze damaged mangroves, *Juncus roemerianus*, *Salicornia virginica*, and upland vegetation on spoil mounds.

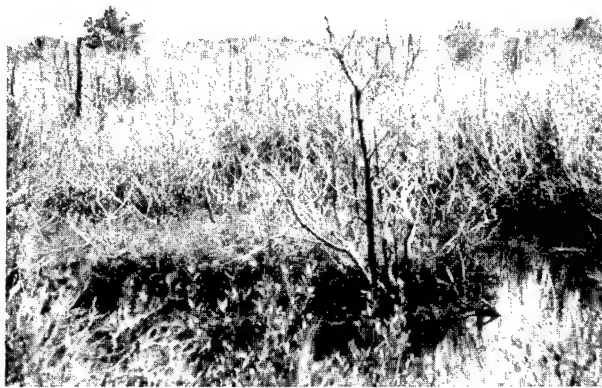
Freeze damaged mangrove habitat at Booth Point site.

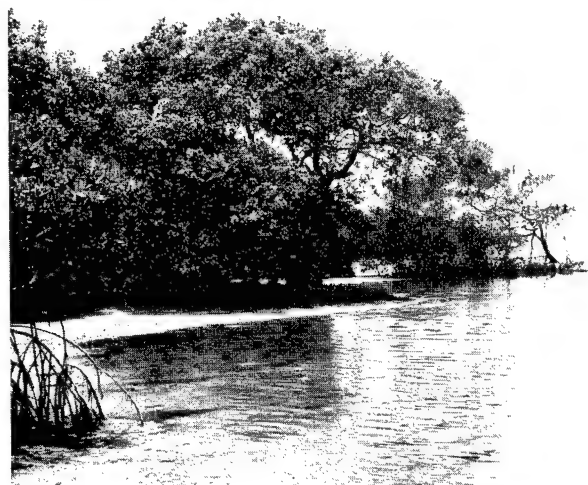
**Figure 103.** Mangrove fringe and tidal flats north of the Perico Bayou site.
